Time-Capsule of Social Change

12 ARTHUR ROAD, MARGATE

Sam Causer - Dossier 1/4 - March 2019
Application for Accreditation as a
Conservation Architect

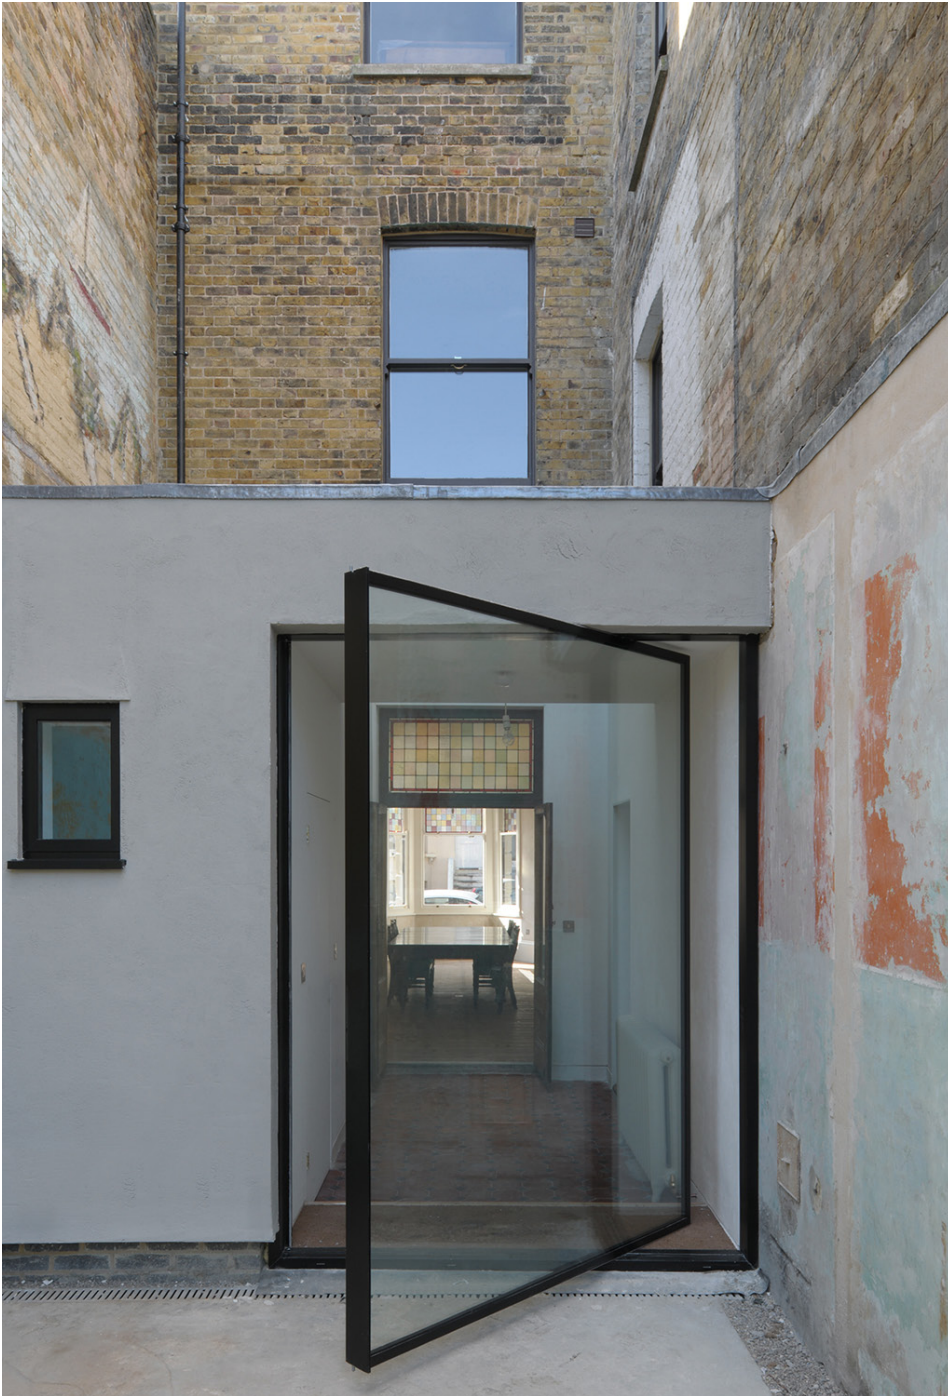
Fig 1.1. View of rear of house, just before completion, with extension in foreground, on footprint of early conservatory, evidenced through the intact quarry tile floor discovered underneath concrete screed.
Photo: David Grandorge.

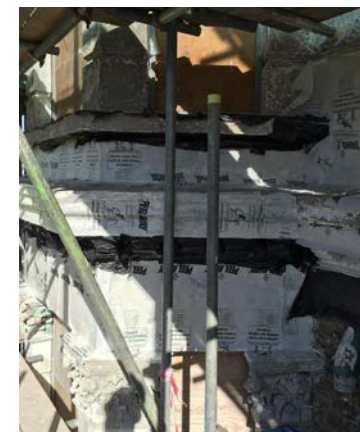
Fig 5.4. Photo 2017, during construction. The condition of the render and mouldings before repair work was carried out by specialist sub-contractor.

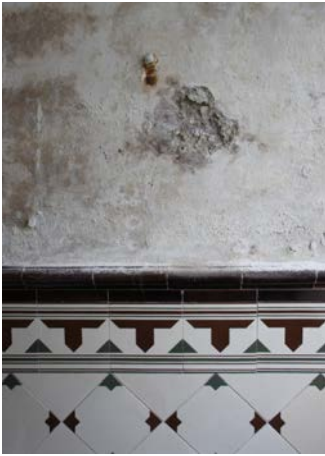
Fig 6.1. Pre-strip out condition of lime plastered brick internal wall with C19th tiling mostly intact.

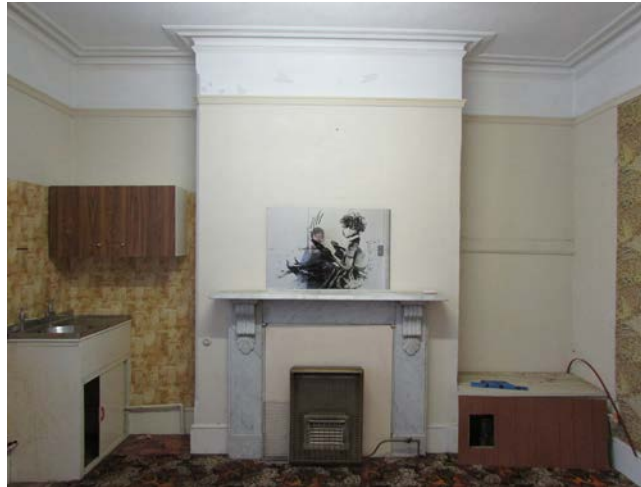
Fig 6.4. Room 1.02 as bed-sit room with kitchenette in the alcove and gas fire. Various wallpapers.

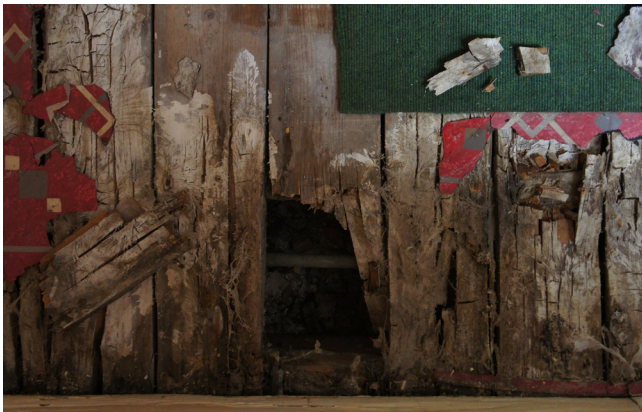
Fig 6.3. The floor of the south east corner of room 1.04 had clear evidence of fungal rot, caused originally by unattended leaking gutter. [f]

The floors throughout the house were in great condition, protected by the layers of lino and carpet laid over. Some local repair works were required, where rot and /or other physical damage had occurred. Areas of fungal rot were treated, then cut out around. We used floorboards from what would become tiled bathrooms to repair other rooms. The remaining floorboards in bathrooms were left intact, and covered in ply sheets to achieve a level finish for tiling. Many of the boards were lifted to install services, so the ceilings could remain intact. Insulation was stuffed into voids to provide greater sound insulation, partly required as there are no carpets envisaged. We sampled many types of treatment to the floorboards, with different levels of sanding and different finishes. I wanted it to look like we hadn't done anything, so instructed a very light sand to make them walkable in bear feet but retain the patina of age. I instructed a Osmo Polyx hard oil wax finish which has a very soft sheen, enough to not show dusty footprints, but appear 'un-finished'. [b,e,f,i,]

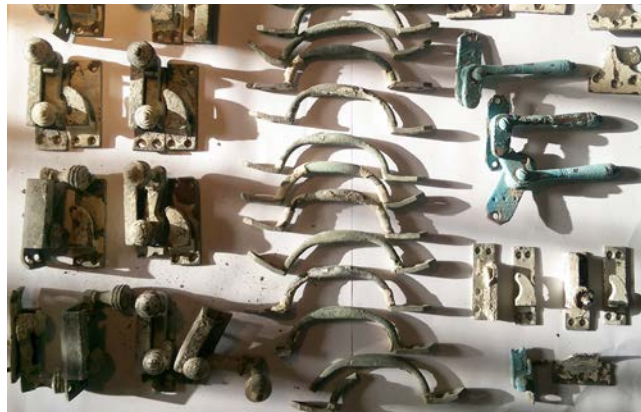
Fig 6.5. I asked the contractor to carefully dismantle all ironmongery to see what could be cleaned, what is still forged / made in similar manner. [d]

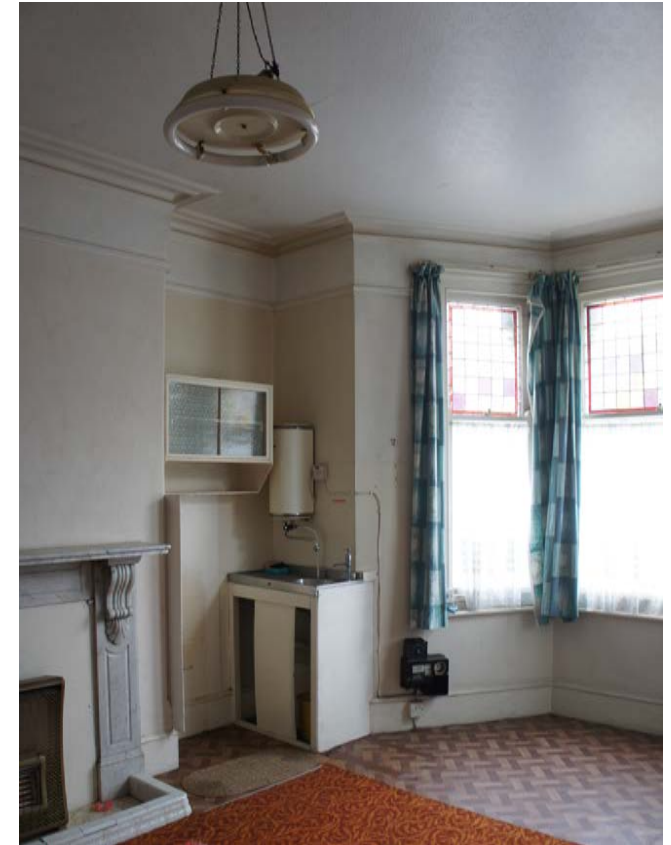
Fig 6.6. Room 1.01 with kitchenette, gas fire, lino and carpet on the floor. Gas cooker has already been removed.

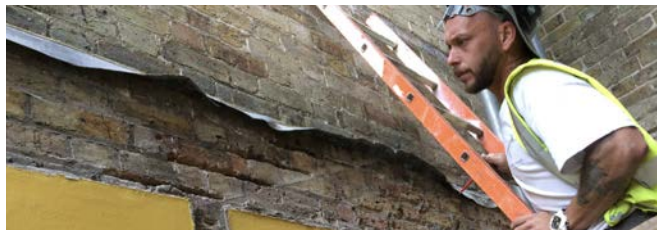
Fig 9.6. Foreperson Simon Aspinall inspecting the existing flashings during demolition, assessing suitability for re-use in same position. Also note scar of historic sloping roof, preceding the flat roof as found in 2015.

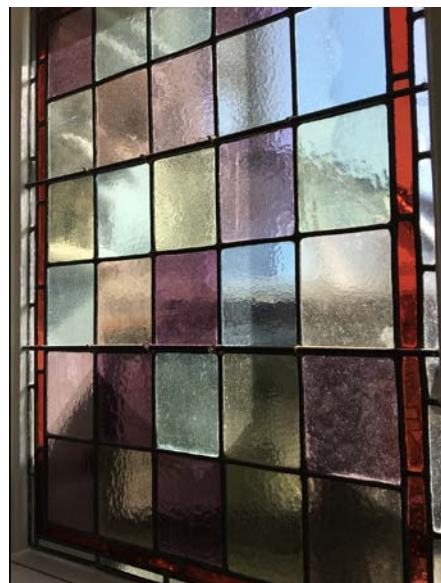
Fig 10.2. Window W1.01A. Stained glass leaded lights restored by local specialist sub-contractor Rob Croudace.

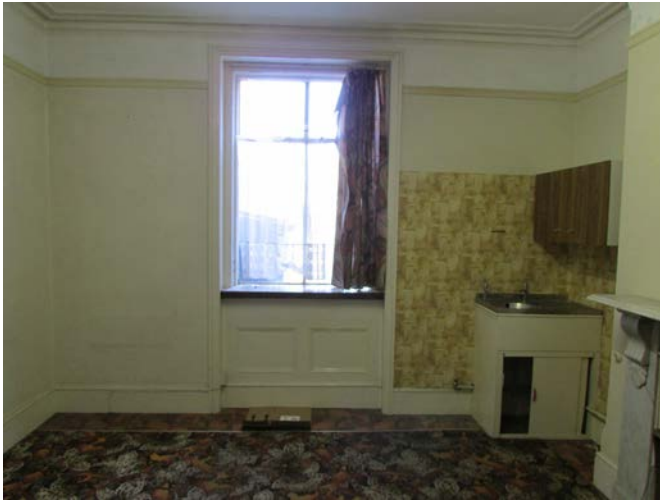
Fig 12.1. Room 1.02. Before strip out.

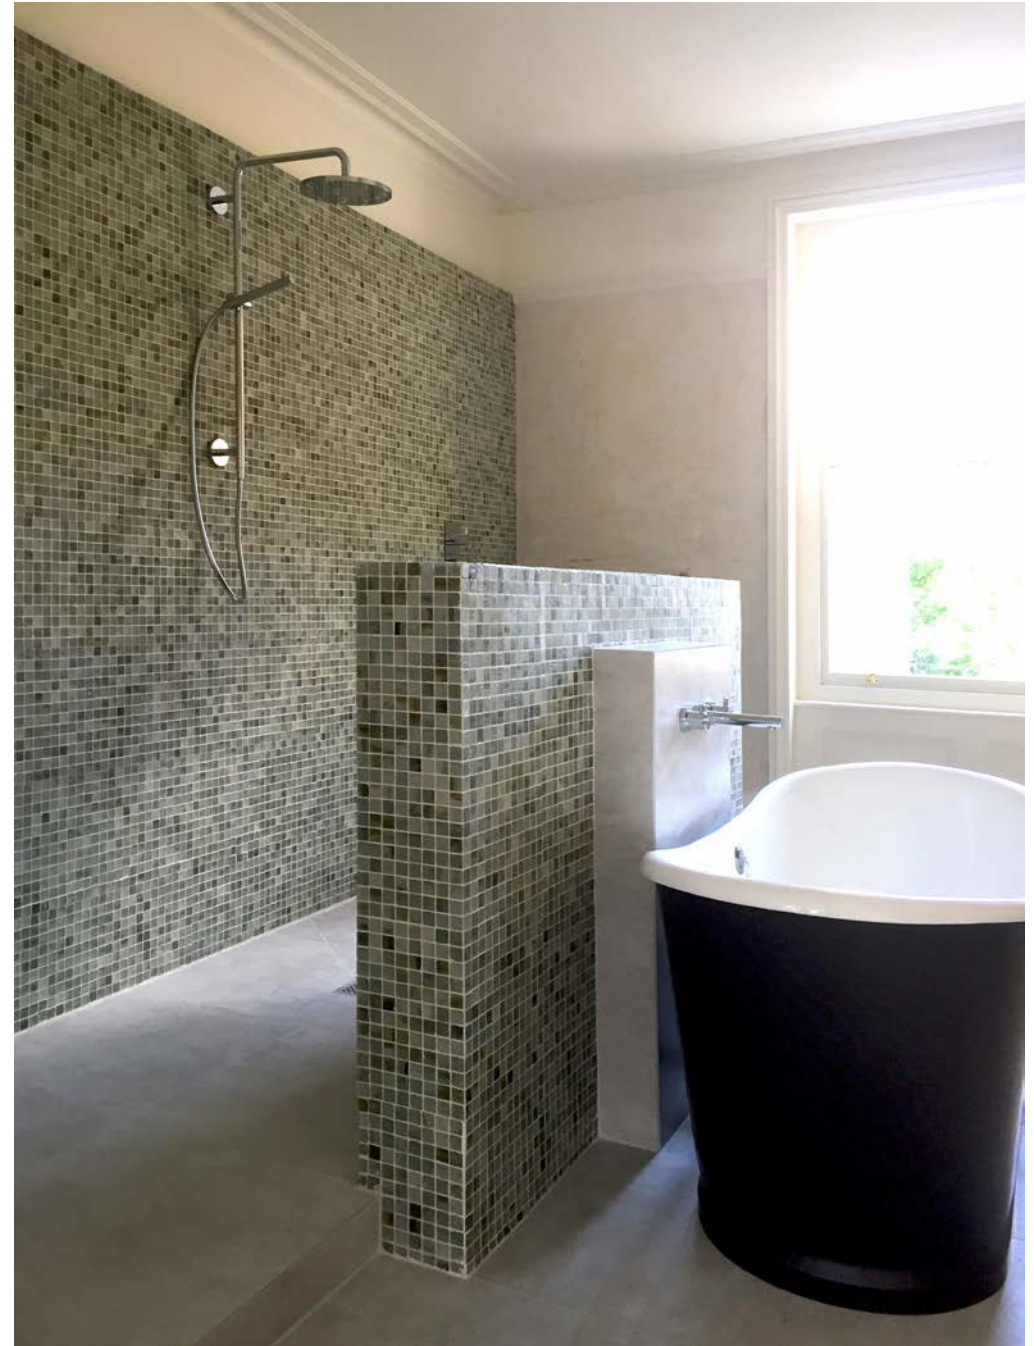
Fig 12.2. Room 1.02. After completion. Note new sliding sash windows with cill lowered to original position. Photo: David Grandorge
