Time-Capsule of Social Change

12 ARTHUR ROAD, MARGATE

Sam Causer - Dossier 1/4 - March 2019
Application for Accreditation as a
Conservation Architect

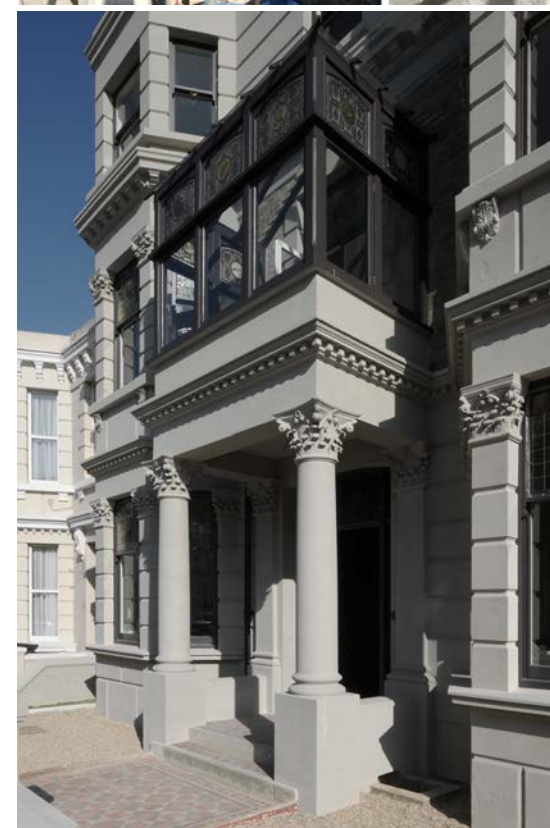
Fig 5.5. Photo 2017, following completion. Photo David Grandorge.

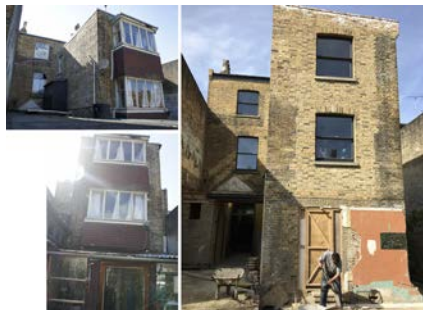
Fig 9.5 (below). Completed rear. Note new single storey extension (LHS) and new brick repairs and infill following removal of bay.

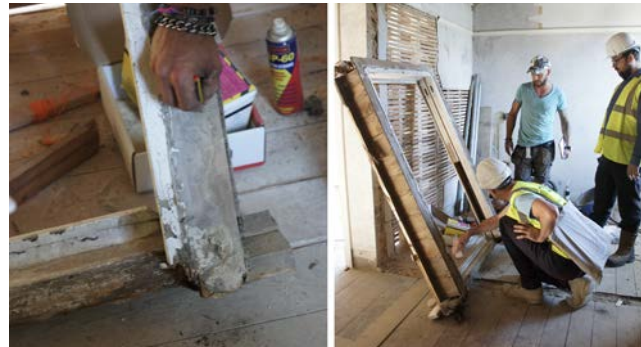
Fig 9.10, 9.11 (below). THI Project Officer, Site Foreperson and Architect (me) inspecting a window frame to agree where repairs need to be made, and how. This is one of the reasonably well preserved 1930s window frames from the top floor front facade. The sashes to the rear had all been replaced in metal in the 1950/60s, and were severely rusted due to lack of maintenance.

The condition of the sash windows to the front facade was found to be reasonable on the whole. I took a careful schedule of condition of each window and minimal repairs were made with timber to match scribed in where necessary. [g]

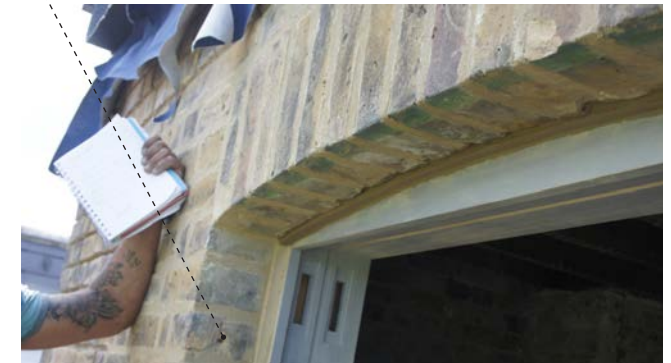
Fig 9.12. New Accoya timber window frame installed in re-pointed brickwork. Looking at the photos now, I see one brick (bottom centre) that I should have instructed to be replaced or turned (if possible) as the end face is badly compromised with what could have been the screw hole to fix the previous metal window frames. [b]

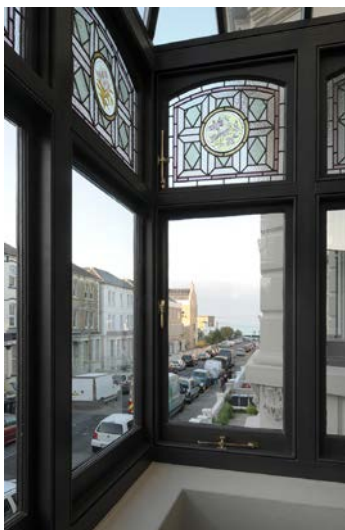
Fig 10.1. Lantern Room 1.08 fully repaired.

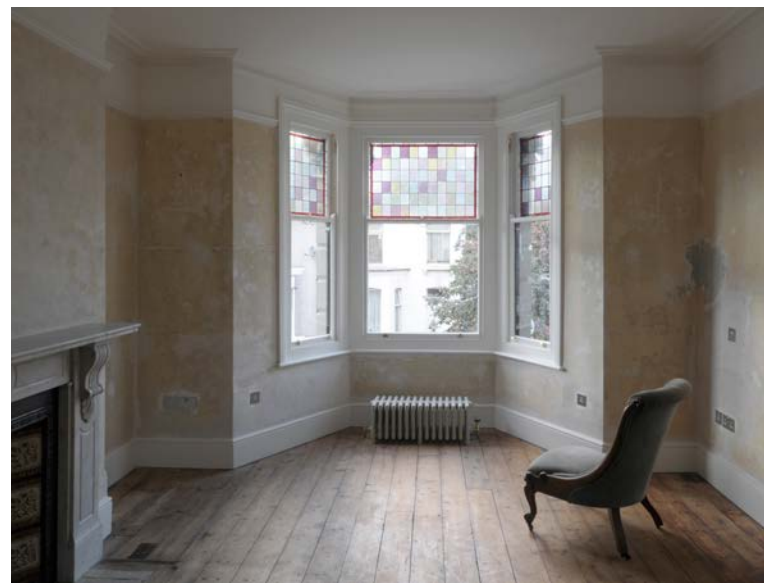
Fig 10.3. Bedroom 1.01 completed. Note the scars on the wall to the left of the bay marking the earlier presence of the kitchenette. Photo: David Grandorge.
