# Conserving a Modenrist Community Space

# KENSAL HOUSE COMMUNITY ROOMS

Sam Causer - Dossier I/I - March 2023 Application for Re-Accreditation as a Conservation Architect

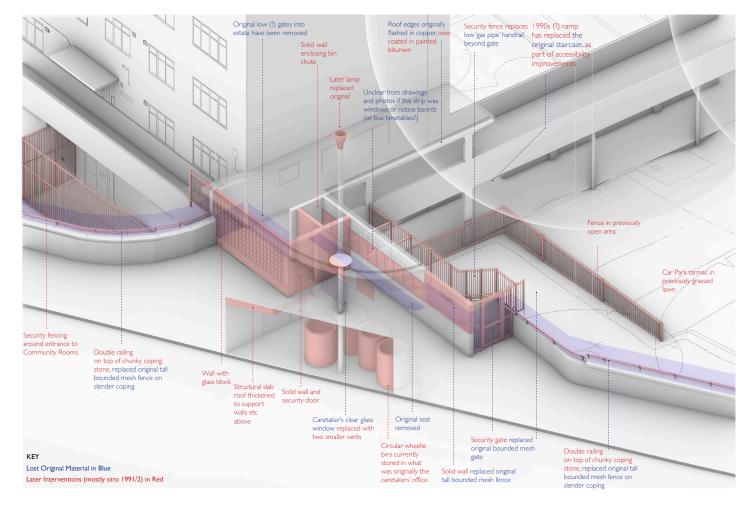
#### Entrance Shelter Isometric

SC's drawing illustrating historic changes to the original entrance shelter (a, c, g, l, h)

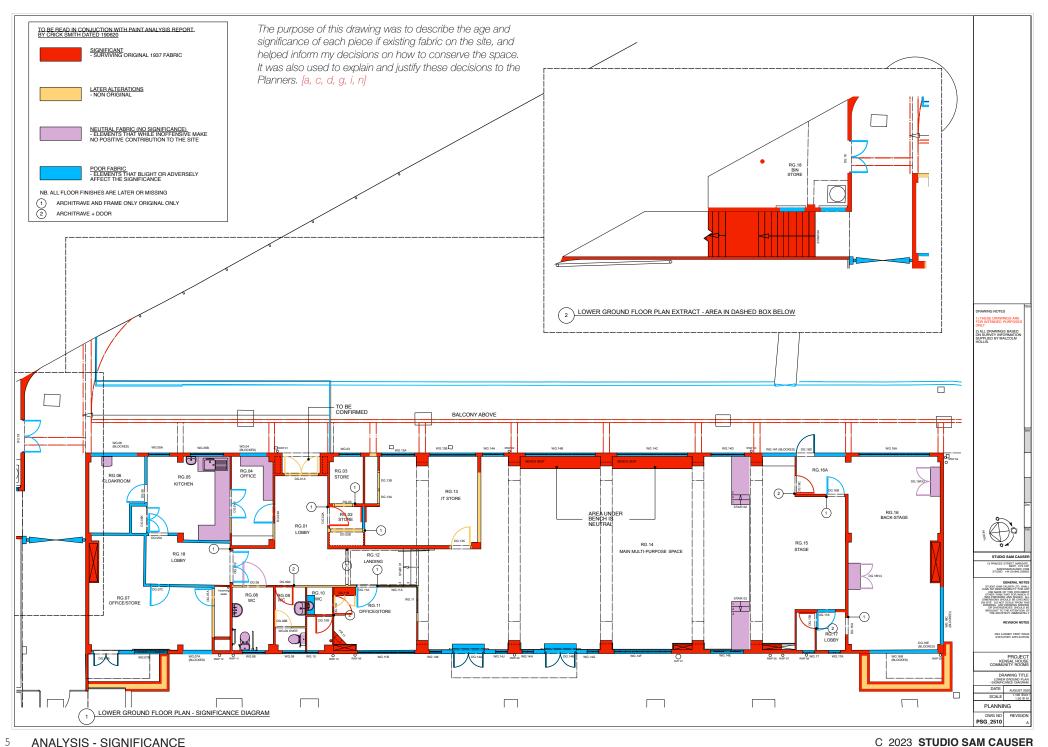
Full west elevation view

ANALYSIS - SIGNIFICANCE C 2023 STUDIO SAM CAUSER This page exploring the existing and proposed materials of the buildling was taken from my Heritage Statement document. [b, c, d, e, f, i, k]

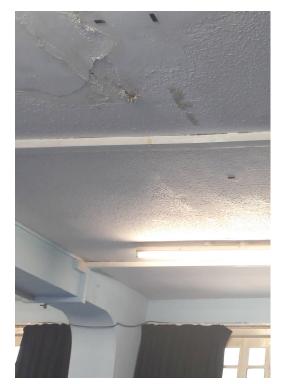
Water damage to existing ceilings

The existing (original) suspended paster ceilings on metal laths are in a poor condition, following a history of water leaks from the flats above the Community Rooms, a common feature of multi-occupancy, high-rise concrete buildings.

These leaks are likely caused by the services to the flats and the broader building, as well as poorly maintained waterproofing to the indented balconies.

We propose to remove all redundant services serving the Community Rooms. However there will be a need for RBKC to trace and address the cause of the leaks from the Landlord's demise.

It has been agreed that RBKC will carry out these remedial works to upgrade / replace leaking pipework and repair all holes from the flat and their balconies above to avoid water ingress.

Following the completion of these remedial works by RBKC, this project will monitor the situation over the construction period before carrying out repairs to the ceiling.

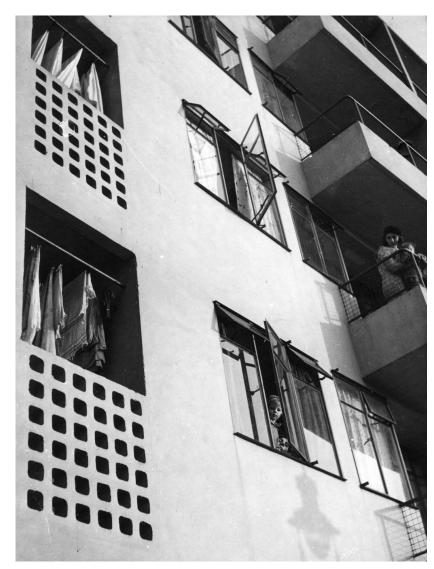
Kensal House. East Block, West Facade. Photograph by Edith Tudor Hart, 1937 (RIBA Collections).

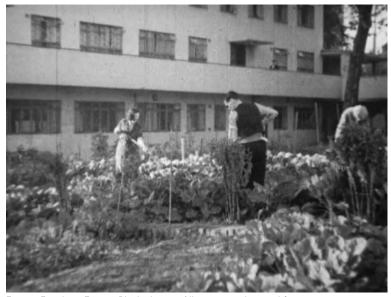
Eastern Facade to Eastern Block, showing Allotments and original fenestration. Kensal House: A Model Housing Estate, 1937 film (National Grid Archive)

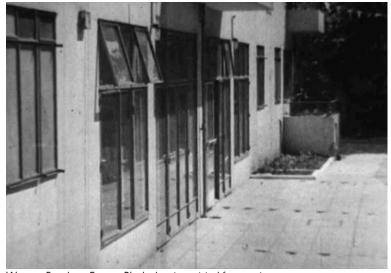
Western Facade to Eastern Block, showing original fenestration. Kensal House: A Model Housing Estate, 1937 film (National Grid Archive)

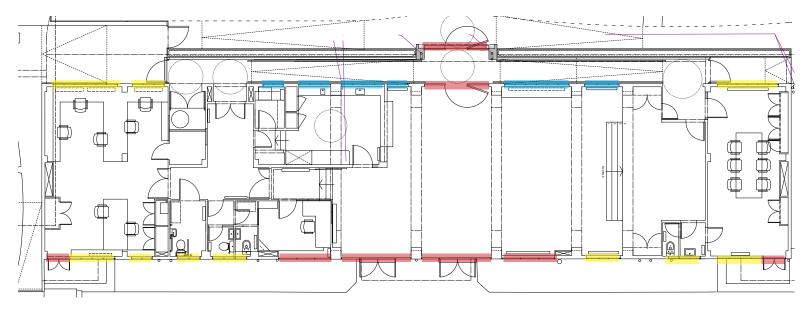
W20 OUTWARD-OPENING WINDOW

W20 INWARD-OPENING WINDOW (FLIPPED OUTWARD-OPENING)

Inward opening slimline profiles are no longer manufactured. Larger inward-opening profiles are generally not recommended due to their poor waterproofing resistance. However where windows are to be made internal by the new glazed corridor below the existing balcony walkway, we are able to install inward-opening windows as per the original lower vents. Inward opening windows will match the details of the outward opening windows, however they will be reversed in the opening. Ironmongery will be located on the existing internal side of the window. This ensures windows along the new enclosed corridor do not form an obstruction in the narrow corridor and can be opened to allow fresh air from the corridor into the Main Multi-Purpose Space. [a, b, c, d, e, f, i, j, k, l, m, n]

Where windows form part of the external envelope we propose outward opening vents only to ensure weather tightness is maintained.

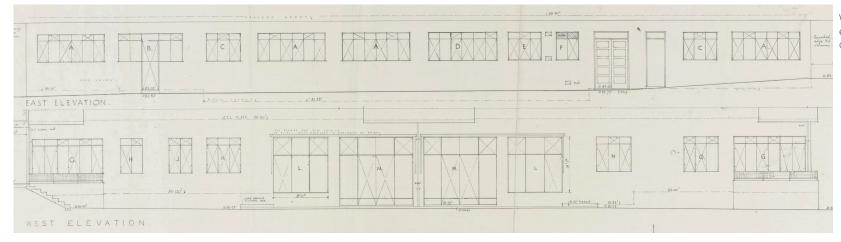
Extracts from Historic Elevation drawing (London Metropolitan Archives) [d]

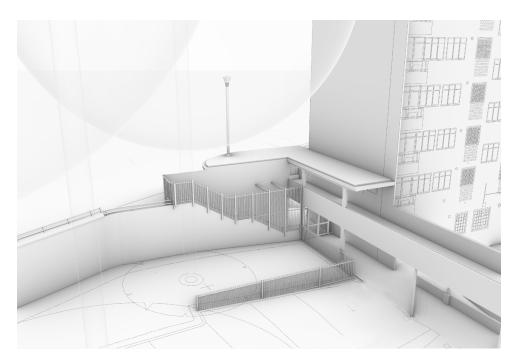
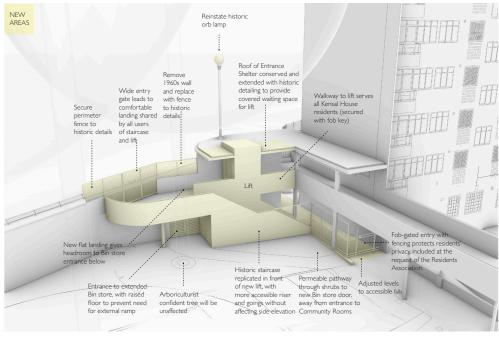
the flats at raised ground level. These diagrams were part Most options included a lift, in various locations, and of a series drawn and labelled by me, based over the 3D other options were for a ramp. The diagram above left is CAD model produced by an assistant under my direction, in the existing condition, and above right is the proposed.

One of the main changes to the original building is led by order to demonstrate that we had carefully considered everyBelow is a selection of some of the alternative options I the need to allow those in wheelchairs, with pushchairs, or possible means of access for those with limited mobility with limited mobility to access their Community Space on from uper ground (street) level down to the Community the lower ground floor. The building does not have a lift, Rooms. [a, b, c, d, g, i, j, k, m, n]. but the original design did allow level access to many of

Through these diagrams, I was able to demonstrate to Historic England and the Twentieth Century Society, as well as the RBKC Planners and Conservation Officer that demolition of the historic staircase, and replacement with a new lift and stair was the most
